2018 KEPIC-Week

Containment Post Tensioning System(CPTS)

[Strand Damage Assessment]

2018.08.30, Rev.0 Nuclear BG

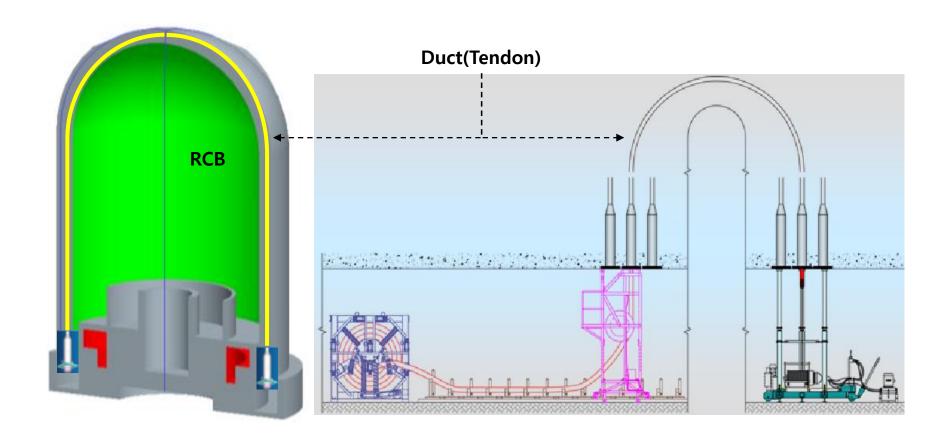
1. CPTS(Containment Post Tensioning System)

To prevent cracks in concrete by applying compressive stress in advance to the structure by tensioning the strands(tendon) inside the reactor building concrete

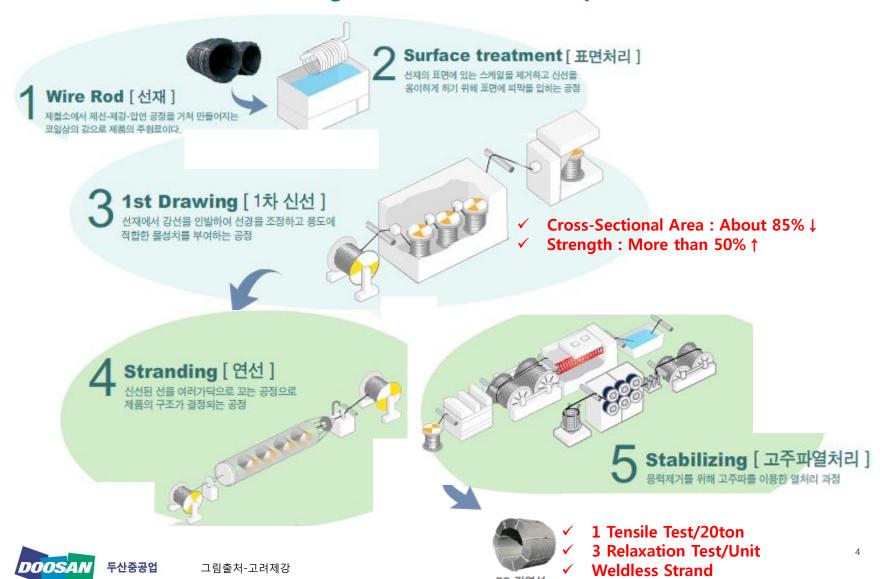
2. Strand and Tendon Fabrication (1/3)

Strand - Continuous drawing and stabilization to prevent local defects

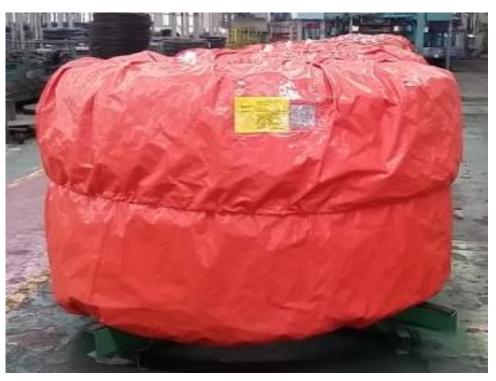
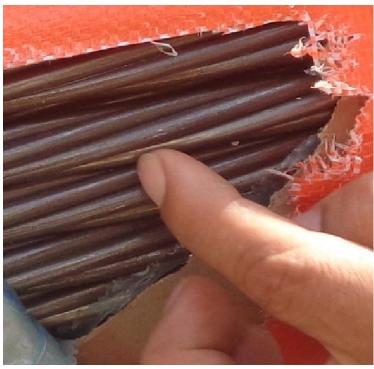
3. Strand Damage Issue

Damaged packaging and scratches on strands in tendon package delivered to the site

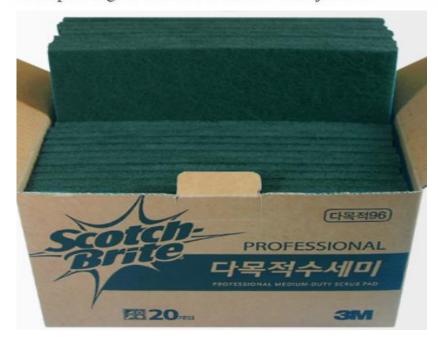
4. Technical Specification/Code/Standard (2/2)

PTI M50.3-12, 11.5 : Picture 1,2 and 3 acceptable(no pitting)

11.5 — Acceptance criteria

Formation of light rust on the strand surface shall not be detrimental. The following test shall be used to determine the acceptability of strand for installation in the ducts.

Use a Scotch Brite Cleaning Pad No. 96—made by 3M—or its equivalent, made from synthetic, nonmetallic material. Hand-clean a strand sample longitudinally with a new pad using moderate pressure. Refer to Fig. 11.1 for evaluation. Based on Pictures 1A, 2A, and 3A, levels of rust shown in Pictures 1, 2, and 3 are acceptable. Picture 4A shows pitting visible to the unaided eye. Hence, rust levels corresponding to Picture 4 are cause for rejection.

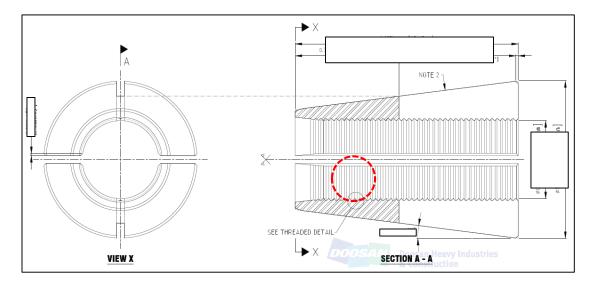
5. System Qualification Test for SKN 3&4 (1/3)

System qualification test satisfied for strand damage up to 0.4mm deep

- **♦** VSL(DOOSAN) Wedge: Thread Depth 0.4mm
- ◆ Qualification tests(KEPIC SNB-2460) @ strand damage 0.4mm deep
 - ➤ Static Tensile Test: 100% Fpu(2 Times, LST & Ambient)
 - ➤ Low Cycle Dynamic Tensile Test: 80%~40% Fpu(50 Cycle)
 - ➤ High Cycle Dynamic Tensile Test: 66%~60% Fpu(500,000 Cycle)

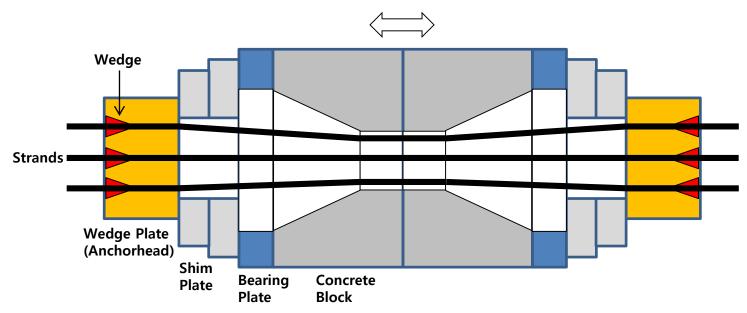
5. System Qualification Test for SKN 3&4 (2/3)

System qualification test satisfied for strand damage up to 0.4mm deep

Static Tensile Test (Ambient & -34°C, 100% of Full Size) (100% MUTS)

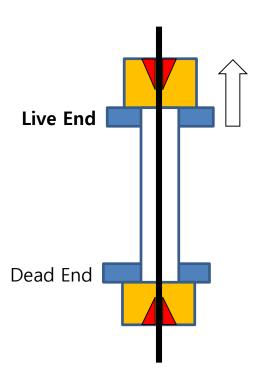
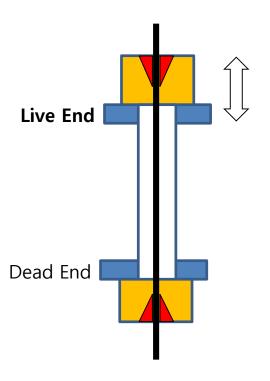
5. System Qualification Test for SKN 3&4 (3/3)

System qualification test satisfied for strand damage up to 0.4mm deep

Dynamic Tensile Test

(10% of Full Size, 500,000@60~66% MUTS)

(10% of Full Size, 50@40~80% MUTS)

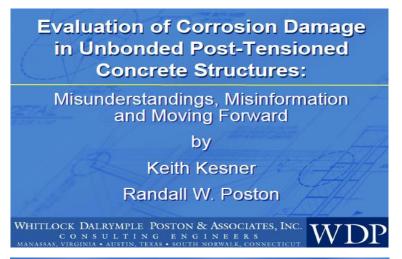
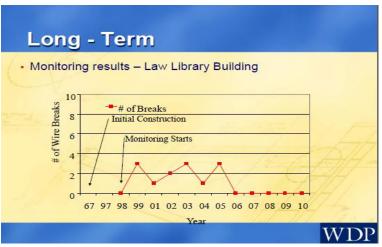
6. PTI 2010 Conference Data (1/2)

No strength loss for strand pitting up to 0.5mm deep

Corrosion Assessment Ultimate Load Testing % GUTS Assembly (kip) - Loss of strength 40.6 98.3 39.8 96.4 - Comparison with 36.0 87.2 101.9 analysis results 39.0 94.4 - Comparison with code 39.2 94.9 40.6 98.3 requirements 41.0 99.3 40.2 97.3 36.2 41.0 40.3 97.6 13 40.2 40.2 97.3 39.7 Average

Corrosion Assessment						
Law School Library – 56 Tendons extracted						
Category	%	Max. pit depth (in.)	Ultimate Strength (kips)	% GUTS		
Failure	3	-	-	13 7 /		
Severe	52	0.04 in.	31.7	77 ///		
Intermediate	11	0.02 - 0.04 in	37.2	90		
Mild / None	34	0.02 in.	40.3	97		
Total	100%		1,2/	4/4

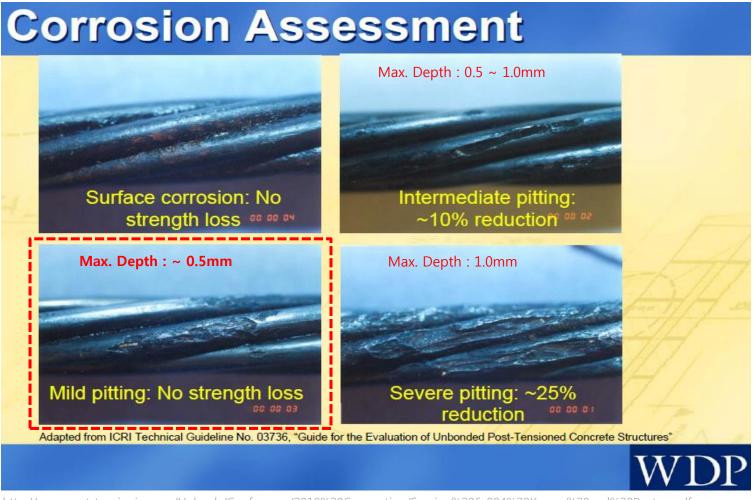
6. PTI 2010 Conference Data (2/2)

No strength loss for strand pitting up to 0.5mm deep

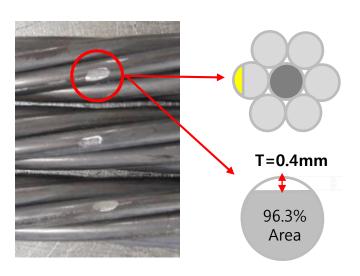
7. Tensile Test for Damaged Strand – 1 Wire (1/3)

1 outer wire damaged(0.4mm deep) - Tensile test satisfied

◆ Actual tensile test result by KISWIRE(30-OCT-2017)

> Strand Size: 0.6in-270-Low Relaxation, 260.7kN

➤ Wire Size(Nominal Diameter) : 5.XX(Center Wire), 5.XX(Outer Wire)

No.	Tensile(kN)	Results
	260.70	Normal strand - 272.49kN
1	261.89	1 wire broken(damaged section)
2	267.65	1 wire broken(gripper section)
3	265.66	1 wire broken(damaged section)

Specimen(damaged)

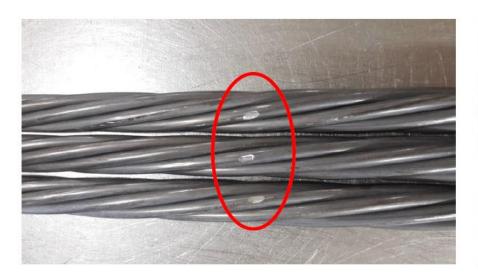
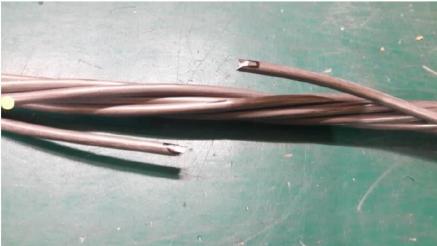
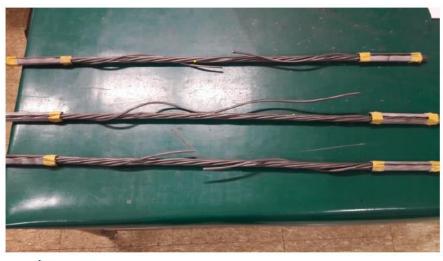
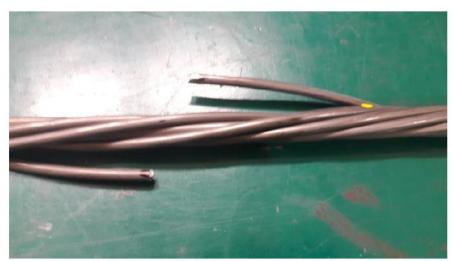
7. Tensile Test for Damaged Strand – 1 Wire (2/3)

1 outer wire damaged(0.4mm deep) – Tensile test satisfied

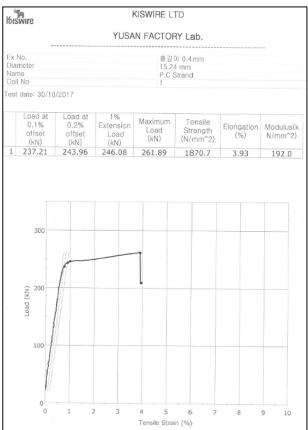
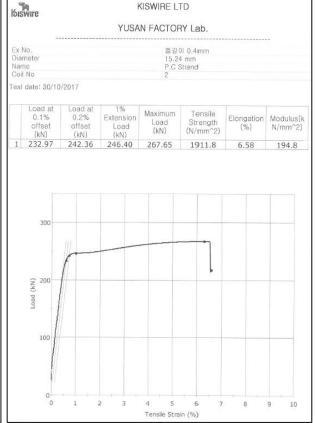
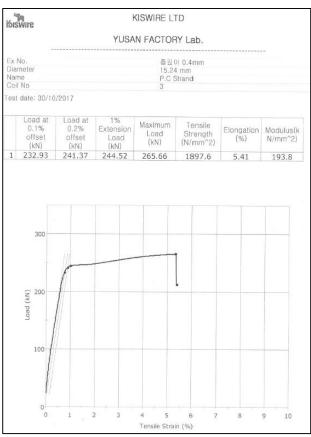
7. Tensile Test for Damaged Strand – 1 Wire (3/3)

1 outer wire damaged(0.4mm deep) - Tensile test satisfied

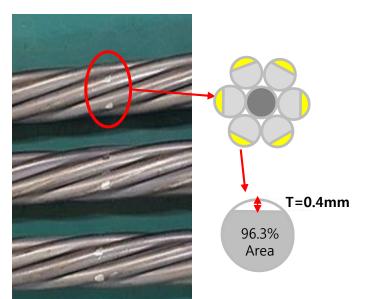
8. Tensile Test for Damaged Strand – 6 wires (1/3)

6 outer wires damaged(0.4mm deep) - Tensile test satisfied

◆ Actual tensile test result by KISWIRE(27-DEC-2017)

> Strand Size: 0.6in-270-Low Relaxation, 260.7kN

➤ Wire Size(Nominal Diameter) : 5.XX(Center Wire), 5.XX(Outer Wire)

No.	Tensile(kN)	Results
	260.70	Normal strand - 272.49kN
1	270.65	1 wire broken(damaged section)
2	270.78	1 wire broken(damaged section)
3	268.30	1 wire broken(damaged section)

Specimen(damaged)

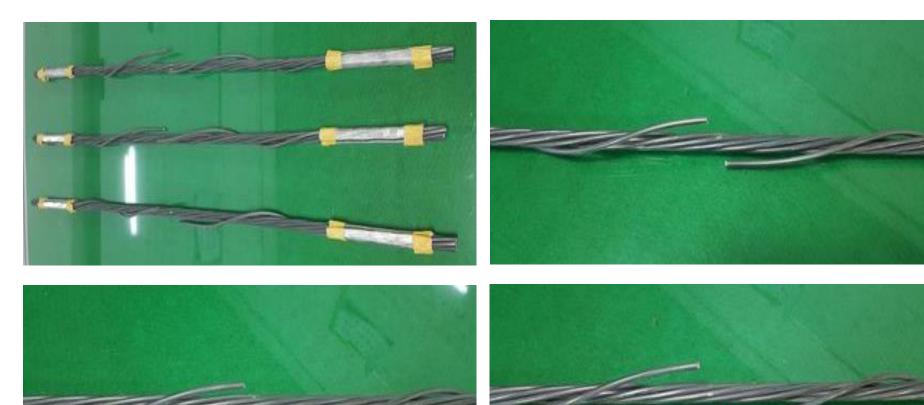
8. Tensile Test for Damaged Strand – 6 wires (2/3)

6 outer wires damaged(0.4mm deep) - Tensile test satisfied

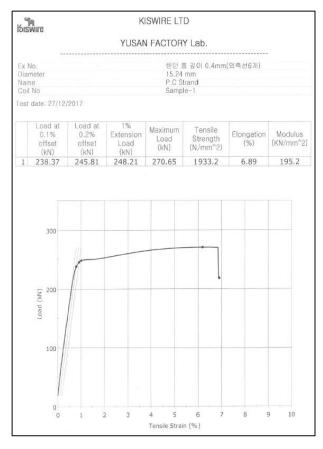
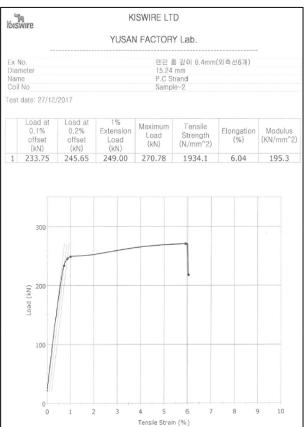
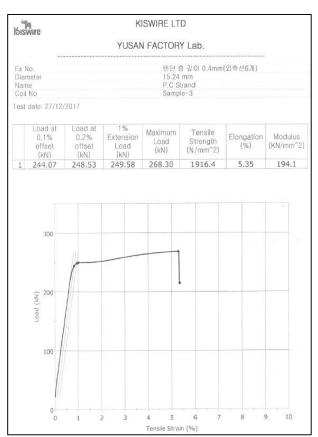
8. Tensile Test for Damaged Strand – 6 wires (3/3)

6 outer wires damaged(0.4mm deep) - Tensile test satisfied

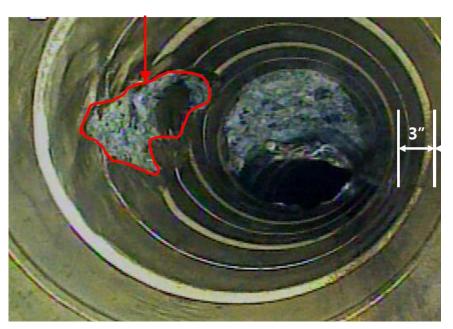
9. Duct Installation Issue (1/3)

Stress concentration and breakage on strand due to kink or dent of duct

[Duct damage and concrete intrusion]

◆ Duct kink or dent is the major causes for strand breakage

- ➤ Video camera inspection results for duct of continuous strand breakage
 - ✓ Abrupt bending of duct
 - ✓ Duct dent due to concrete or rebar
- ➤ No failure of tensile tests for strand samples supplied at site for the last 18 years(More than 12 Reactor Containment Building)

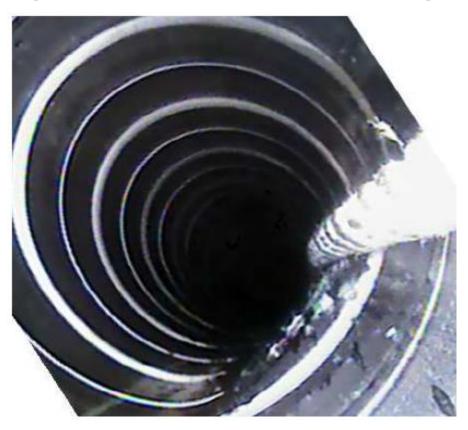
9. Duct Installation Issue (2/3)

Stress concentration and breakage on strand due to kink or dent of duct

[Duct dent due to rebar or concrete]

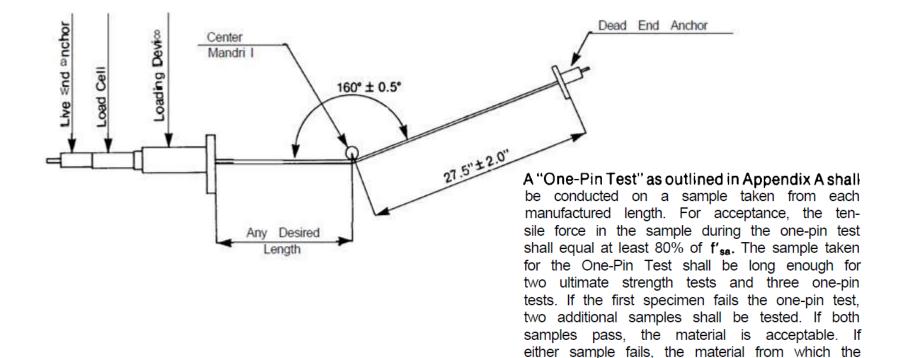
FIGURE A.1 BASIC DETAILS OF PIN TEST DEVICE (FOR STAY CABLE)

Stress concentration and breakage on strand due to kink or dent of duct

SEE FIGURE A.2 FOR DETAIL OF CENTER MANDRIL

[PTI Recommendations for stay cable design and testing-1986]
